REMMERS EPOXY FAS 100

Reliability Under Extreme Conditions

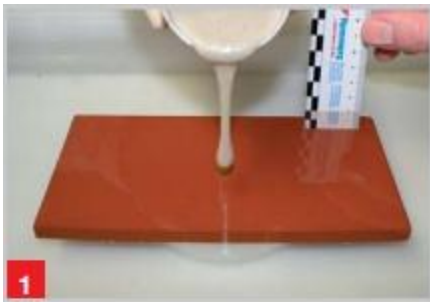
1 The mixed primer based on Remmers Epoxy FAS 100 was applied to the clinker tile through the water.

A clinker tile with a smooth surface was attached 2 cm below the water level. The primer was then poured through the water onto the clinker tile where it was supposed to adhere and then withstand the hardest impact loads. The result? See for yourself!

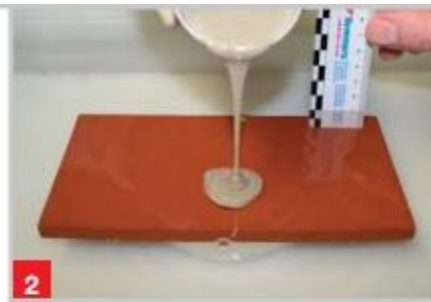
2 The primer and the water do not react with each other allowing successful application.

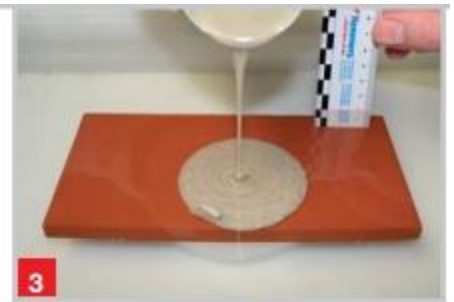
3 Even under water, the substrate is covered by the primer. The water underneath the primer is displaced.

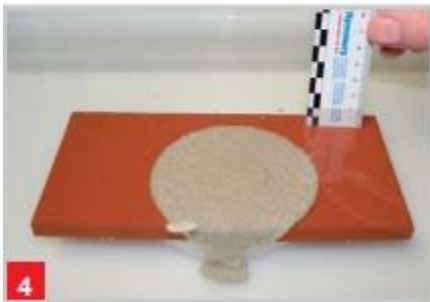
4 Everything runs smoothly: The primer distributes itself evenly and forms a tight **bond** with the clinker tile.

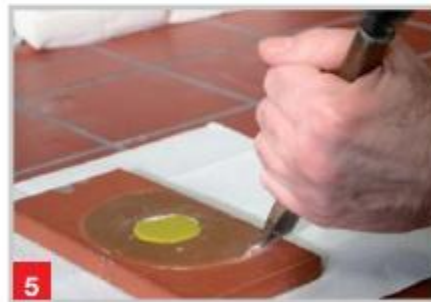
5 After curing, the primer and substrate have become an inseparable unit. The subsequently applied (yellow) coating adheres perfectly and reliably. Even if force is used, it is not possible to detach: The bond holds...

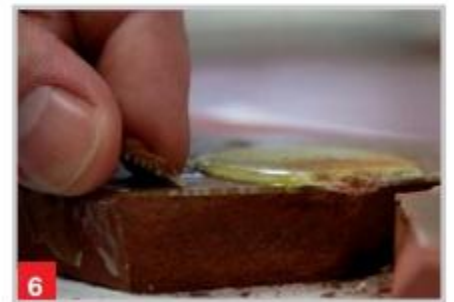
6 ... and the clinker tile breaks! The quality is in the detail. Even after breaking off, the primer is still bonded to the tile. So even if an area became damaged, the damage would not spread.
